# Manhole Inspection Summary

Manhole # S31G\_\_019MH

Insp Date: **11/12/08 10:26 AM**

**Location** Address: **29 s green st**

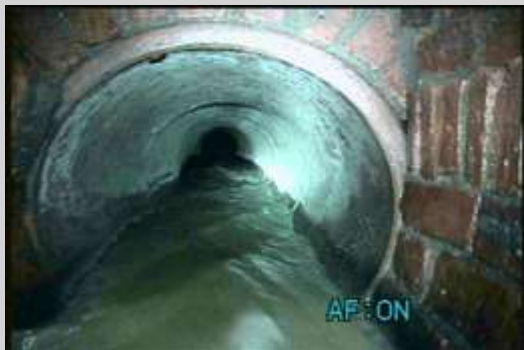
12 O'Clock Outflow

15 in. Circular Gravity Sewer  
Pipe Out @ 12 O'Clock

Pipe Material: **Clay** ☐ Pipe Lined

Invert Depth: **25.10** (ft.) Flow Characteristics: **Fast**

Deposits: ☒ None ☐ Mud ☐ Sludge ☐ Debris ☐ Grease

Infiltration: **None** Pipe Seal Cond: **Unknown**

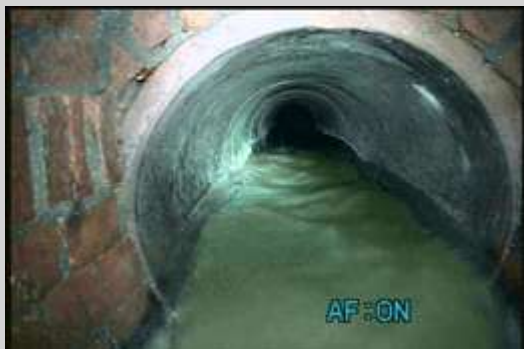
6 O'Clock Inflow

15 in. Circular Gravity Sewer  
Pipe In @ 6 O'Clock

Pipe Material: **Clay** ☐ Pipe Lined

Invert Depth: **24.92** (ft.) Flow Characteristics: **Fast**

Deposits: ☒ None ☐ Mud ☐ Sludge ☐ Debris ☐ Grease

Infiltration: **None** Pipe Seal Cond: **Unknown**

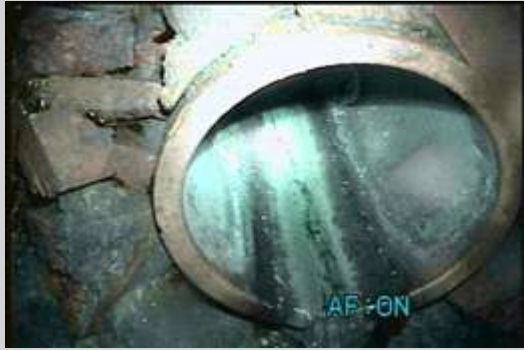
9 O'Clock Inflow

10 in. Circular Gravity Sewer  
Pipe In @ 9 O'Clock

Pipe Material: **Clay** ☐ Pipe Lined

Infiltration: **None** Pipe Seal Cond: **Unknown**
